Container crane boom collapse: Cause and prevention

Erik Soderberg, SE, Principal, Liftech Consultants Inc., Oakland, CA, USA

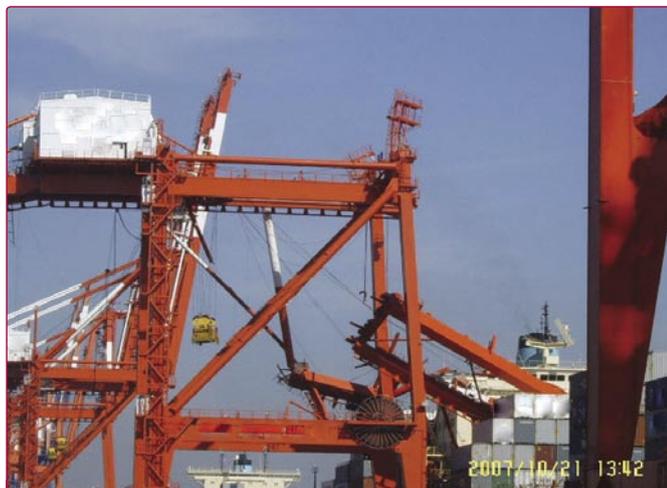
Figure 1. Crane boom failure. Asia – October 2007.

No cause has been definitively identified in either of the failures shown in Figures 1 and 2. Some of the usual suspects have been identified though: rope failure, sudden drop due to rope bird nesting, gusset plate failure, or other connection failure. Since the failures occurred when the booms were supported by the hoist ropes, and the maximum stresses in the boom support structure occur during vessel operations, the most likely cause was boom hoist rope failure.

In the Asian boom failure, the hoist rope may have failed due to previous damage or overload. We will never know the cause.

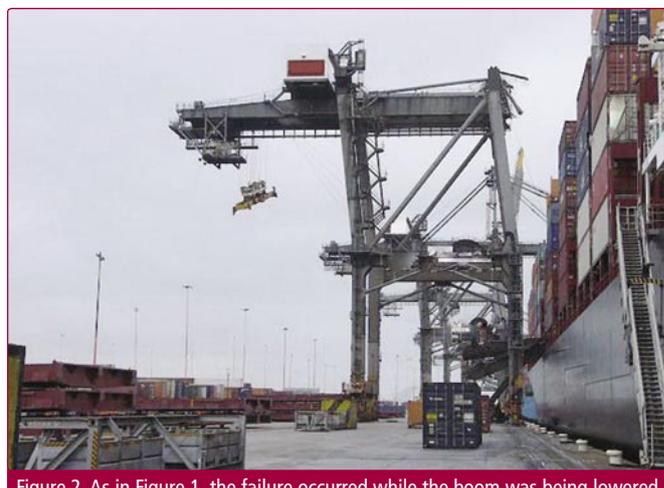
Figure 2. As in Figure 1, the failure occurred while the boom was being lowered. Europe – January 2008.

In the European failure, the accident report issued immediately

after the failure stated that as the boom was being lowered, a loud crack was heard just before the apex and boom fell. Videos of this failure indicate that the boom was almost fully lowered when the failure occurred. The cracking sound would indicate there may have been a brittle failure in a cracked plate or member. The video neither supports nor refutes this cause. Again we will never know the cause.

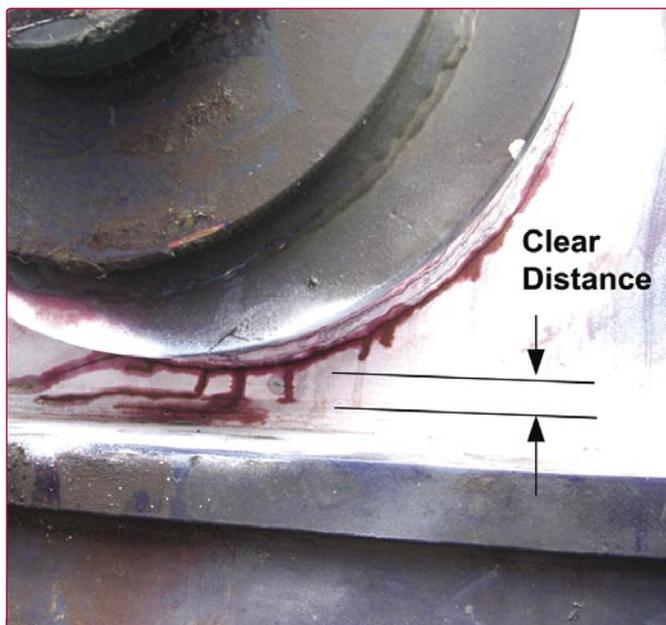
Figure 3. Fatigue crack at forestay-to-boom connection plate.

As discussed above, weak axis bending in gusset and link plates in the boom support system can result in significant stresses. Inadequate clear distances between welds have resulted in extensive cracking and failure at the forestay-to-boom connection plates. Refer to Figure 3 and Diagram 1. The weak axis bending stresses are linearly proportional to the plate thickness and inversely proportional to the plate clear distance squared. Doubling a plate thickness will double the weak axis stress; tripling the clear distance will reduce the stress by a factor of nine.

The distance between the weld toes should be enough to keep the weak axis fluctuating stresses below the fatigue threshold.

If this is done, the weak axis stresses are negligible and need not be considered with axial stresses. Detailed calculations are needed to determine the minimum distance. In most cases a distance of five times the plate thickness is adequate. If the clear distance is less than three thicknesses, calculations should be made to ensure the effect of lateral stay motions has been accounted for in the design. Of course, each situation is different; sometimes a clear distance of five thicknesses is more than adequate and sometimes it is not.

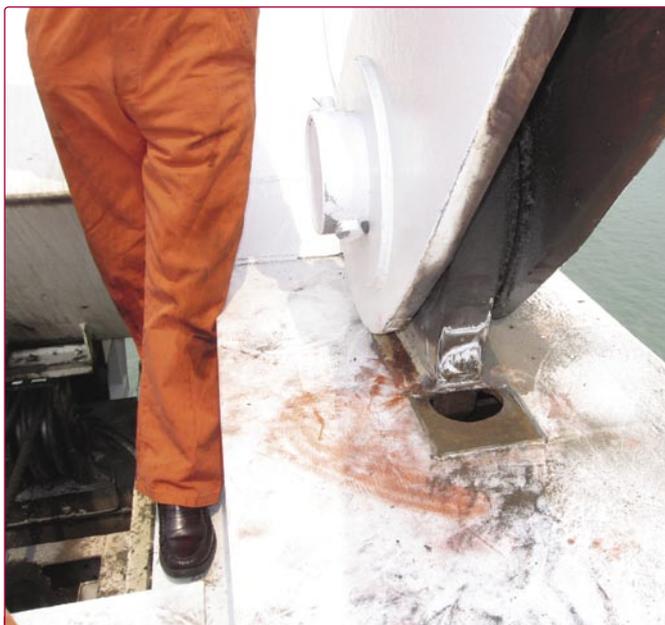
Figure 4. Relief hole at inner forestay-boom connection.

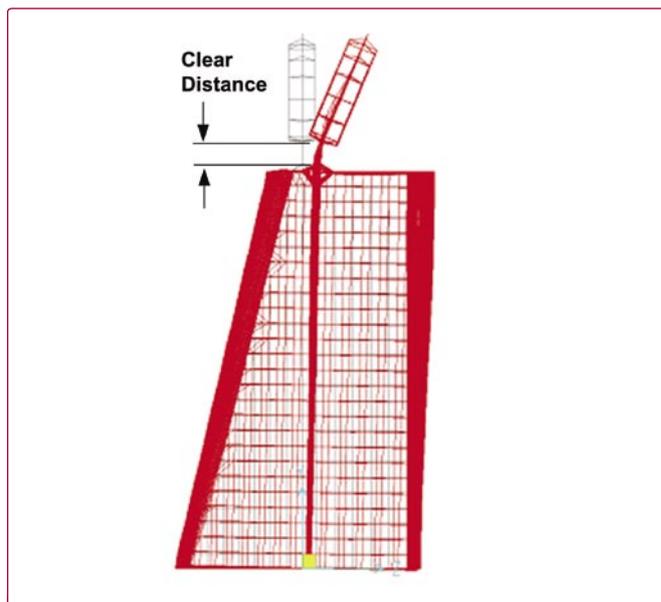
Diagram 1. Exaggerated weak axis bending of forestay-to-boom connection plate.

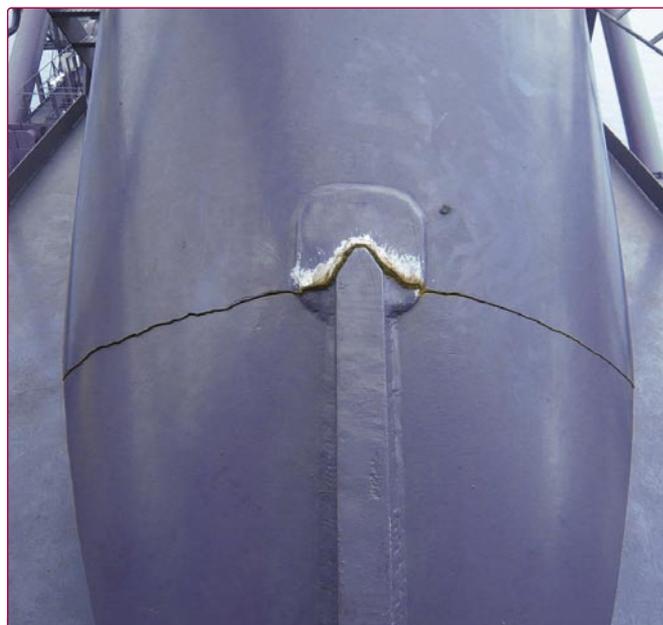
Large stress concentrations at plate connections may occur if the gusset plate is slotted into another plate. Serious fatigue cracking has occurred in these areas due to inadequate design, fabrication, or both. Special care is needed at locations where plates are contoured for smooth stress flow. If the contours are not smooth, the stress flow will not be smooth. Refer to Figure 5 for a crack caused by poor fabrication.

Recent cracking on two different crane designs resulted in dangerously long cracks in fracture critical members (Figure 5). Fortunately, failure did not occur because the materials are significantly tougher than specified and because inspections detected the cracking.

Figure 5. Fatigue crack at upper diagonal stress relief hole.

The plate-in-a-slot connection detail must be carefully designed and fabricated since this connection detail has many localized discontinuities that affect its fatigue performance. Some considerations include the following:

1. Relief hole geometry and surface texture.

2. Cover plate geometry, surface texture, and weld geometry, quality, and inspection.
3. Consider the fracture critical crack length when designing the cover plate. While it is desirable to keep the cover plate weld away from the high stresses at the relief hole, it is also undesirable to cover a crack emanating from the relief hole.

If necessary, provide a relief hole cover plate with a removable plug to permit inspection using a Boroscope.

For an existing crane, an owner should increase the inspection frequency as needed to maintain the required reliability, modify the connection relief hole and cover plate, or both.

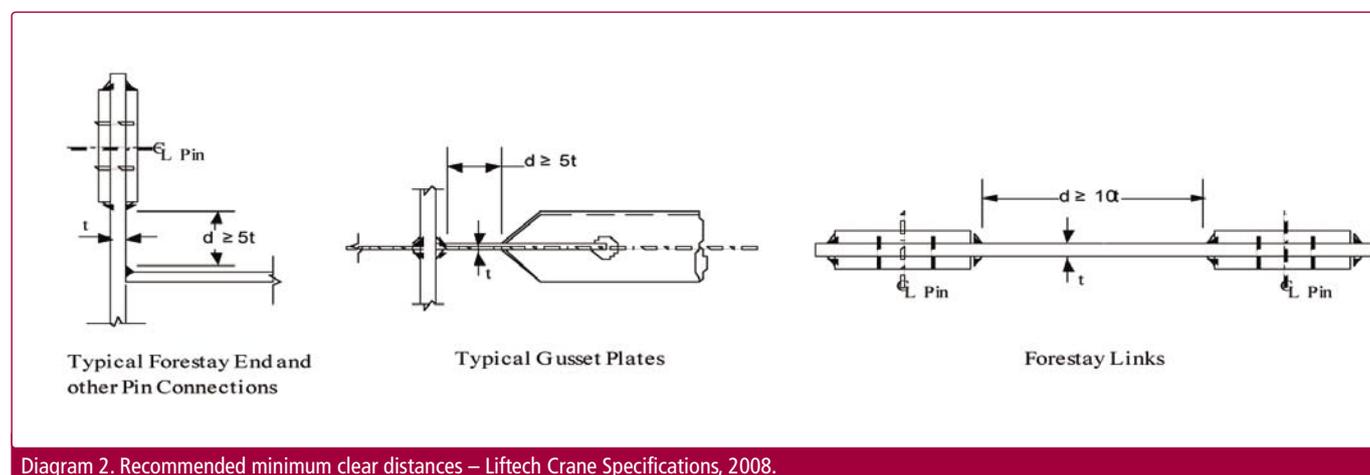
Diagram 2. Recommended minimum clear distances – Liftech Crane Specifications, 2008.

Consider weak axis bending in plates due to wind and other lateral loads. The effect of tension on the bending stresses must be considered. Some guideline minimum clear distances are provided in Diagram 2 that are acceptable for most connections. Of course each situation is different; sometimes a clear distance of five thicknesses is more than adequate and sometimes it is not.

For an existing crane with plates that have clear distances less than three times the plate thickness, increase the inspection frequency as needed to maintain the required reliability, modify the structure to increase clear distances, or both.
