Microbiologically influenced corrosion of pilings

Brenda J. Little, *senior scientist for marine molecular processes*,
Richard I. Ray, *physical scientist and Jason S. Lee, materials engineer*,
Naval Research Laboratory, Mississippi, United States

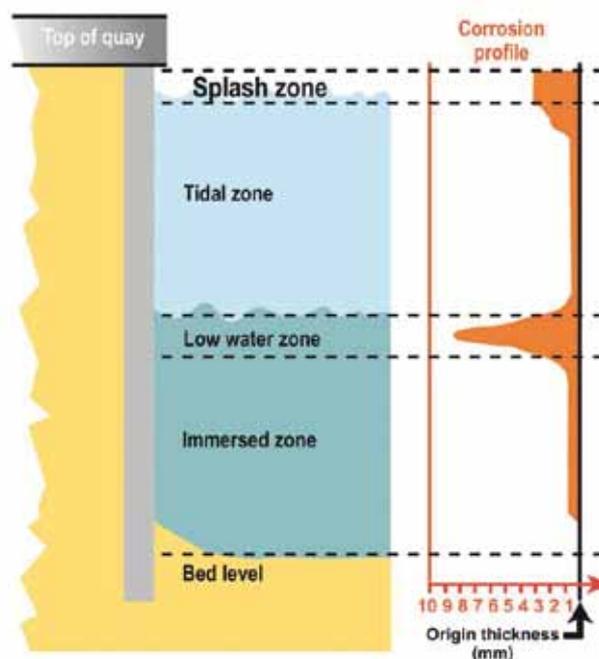
Figure 1: Schematic of ALWC illustrating relationship of water level and degree of corrosion. Taken from Kopczynski (PTI 2010).

The term ALWC does not define a corrosion mechanism. Instead the term denotes the precise location of the corrosion on the exposed pilings (see

Figure 1). Average corrosion rates in the range of 0.3 to 1.2 millimetres per side per year have been reported. ALWC has a distinct appearance, patches of lightly adherent, bright orange and black (iron sulphide rich) deposits over a clean, shiny and pitted steel surface.^v

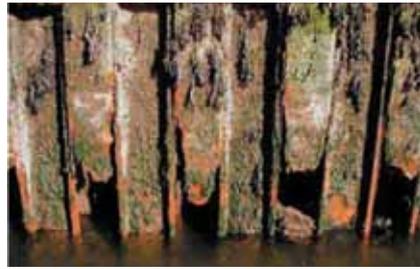
Figure 2a: (Left) Piling deterioration due to ALWC. Figure 2b: (Right) Corrosion of piling in Duluth Superior Harbour.

A report by Gehrke and Sand concluded that ALWC was due to the combination of sulphate-reducing bacteria (SRB) and sulphur oxidising bacteria (SOB) in the fouling layers on the pilings.^{vi} The organisms co-populate the same spatial regions on the pilings. At low tide the biofouling layer is oxygenated whereas at high tide anaerobic areas develop. Sulphides produced by SRB are converted to sulfuric acid by SOB, creating an extremely corrosive environment. (see Figure 2a).

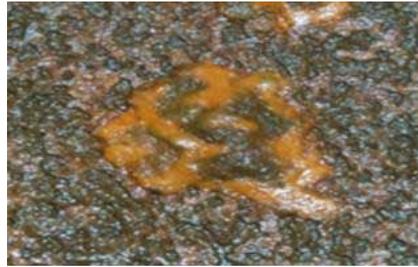
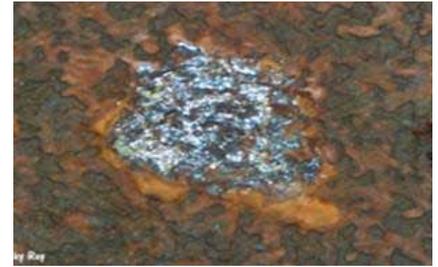
Figure 3: Tubercle on carbon steel exposed in Duluth Superior Harbour before (left) and after (right) removal of tubercle.

A 2009 study has demonstrated that corrosion of carbon steel pilings in DSH was due to deposition of copper under tubercles of iron-oxidising bacteria (IOB). IOB oxidise iron and produce dense deposits of intact and/or partly degraded remains of bacterial cells mixed with amorphous hydrous ferric oxides. A galvanic couple was established between the copper layer and the iron substratum. In laboratory experiments, the galvanic current depended on the concentration of dissolved copper in the lake water.^{xi} A recent study used genetic techniques to quantify the abundance of IOB at multiple sites in the DSH over multiple

years. They demonstrated that tubercles in the DSH were enriched with IOB compared to the biofilm on adjacent surfaces. However, long-term corrosion was not related to IOB abundance or dissolved copper concentration.^{xii} Both studies concluded that a combination

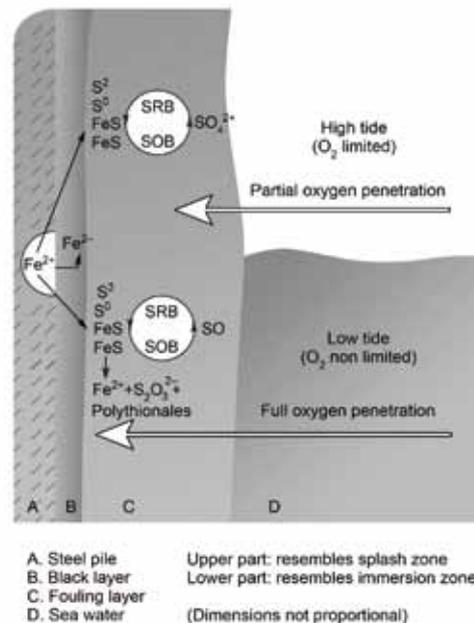
Figure 4: Schematic representation of the chemistry and reactions associated with ALWC. Reproduced with permission from NACE International, Houston TX. All rights reserved. Copyright NACE International 2003.

per-year and higher. However, there are obvious differences in the observations in DSH and reports of ALWC (see Figure 4). ALWC is in the low water zone, just below the tidal zone, in saline waters containing gram per litre quantities of sulphate. DSH is a fresh water harbour with milligram per litre concentrations of sulphate. Corrosion in DSH is localised to the top 3 metres below the surface of the water and water depth is not significantly influenced by tides. Despite these differences both ALWC corrosion and corrosion in DSH have been attributed to MIC. In both cases, a combination of biological, chemical and physical events contribute to the corrosion. The specificity of metal/microbe/electrolyte interactions makes it difficult to predict the likelihood and rate of MIC in harbours. MIC on CS pilings can be prevented.
