Rapid design and construction of sheet piling weir protects Florida water control structure

Kathleen Collins, P.E., USA; Michael DelCharco, P.E.; Taylor Engineering, Inc., USA; & Richard J. Hartman, Hartman Engineering, Clarence, NY USA

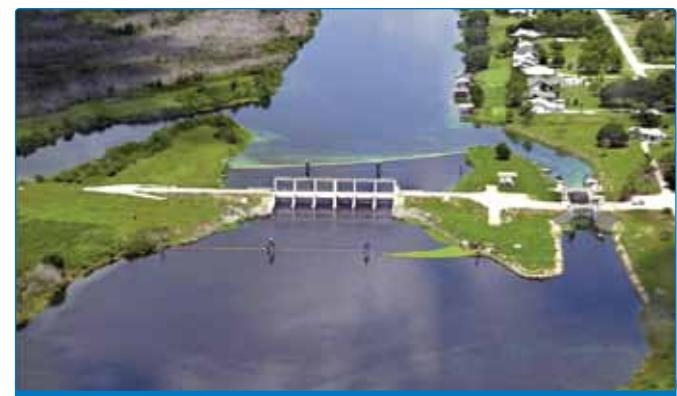
Figure 2. Photograph of Structure S-65E looking upstream (courtesy SFWMD).

Of particular concern was Structure S-65E which is shown in Figure 2. A scour hole 200 feet long by 200 feet wide and 10 feet deep had developed downstream of the structure.

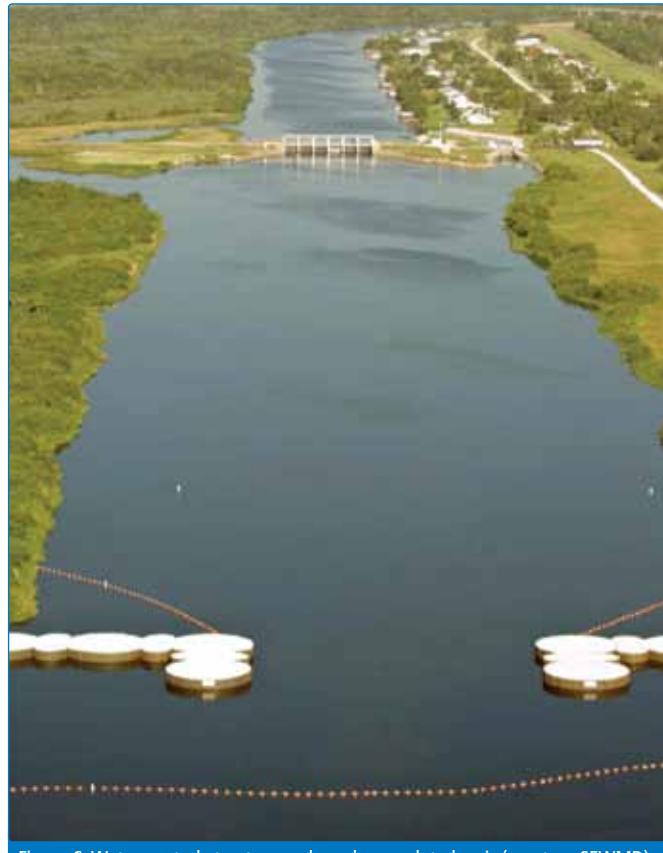
Figure 6. Water control structure and newly completed weir (courtesy SFWMD).

The concrete slab, approximately 200 feet by 90 feet by eight feet deep, was placed as two two tremie pours. Each pour involved placing approximately 2,700 cubic yards of concrete and was performed at night in order to facilitate batching and transportation of the concrete. The newly completed weir structure and the water control structure it protects are shown in Figure 6.

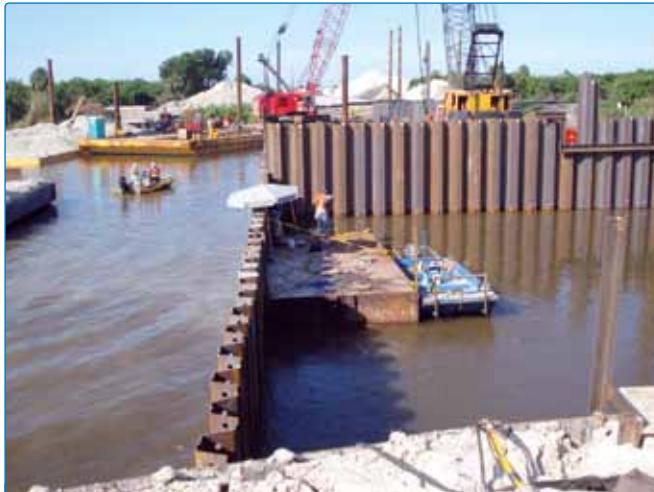
Figure 5. Sheet piling weir and separator wall during construction (courtesy SFWMD).

approximately 90 feet apart. Between the two walls is an eight foot thick concrete slab which was installed as a tremie pour. It was necessary to install the sheet piling walls and the concrete slab in two segments in order to maintain the flow of the river. The two segments of concrete were separated by a third sheet piling wall. Figure 5 shows one of the sheet piling weir walls and the separator wall prior to final driving and cutoff.
