Dredging in China under strict environmental controls

L.J. Nipius, Boskalis/Hydronomic, Papendrecht, The Netherlands & R. Rijnbeek, CNOOC and Shell Petrochemicals Company Limited, Daya Bay, Huizhou, Guangdong Province, China

Introduction

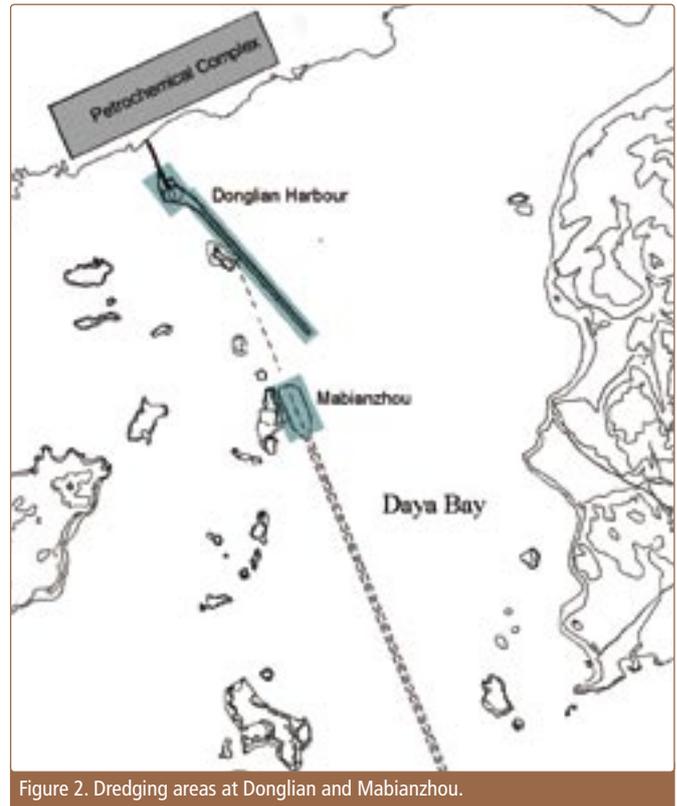
Figure 2. Dredging areas at Donglian and Mabianzhou.

the range of 60,000 to 80,000 DWT. The dredging works for the dolphin berth involved the deepening of a berthing area and turning basin to a water depth of approximately 15 metres.

Additional imports and product export of the complex takes place through a dedicated jetty adjacent to the complex site on the northern shore of Daya Bay. The construction of this jetty at Donglian Harbour required dredging of a berthing area, turning basin with connecting area and approach channel to a water depth of approximately 10 metres.

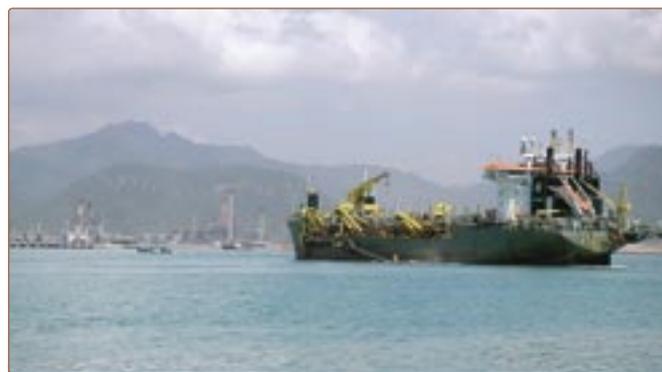
Figure 3. Queen of the Netherlands dredging in Daya Bay.

In July Boskalis' large size TSHD 'Queen of the Netherlands' was mobilised to dredge the turning basin and berthing area near the Mabianzhou dolphin berth. After five weeks the trailer was demobilised again and NCWEB's small trailers completed the remaining dredging close to the dolphin berth.

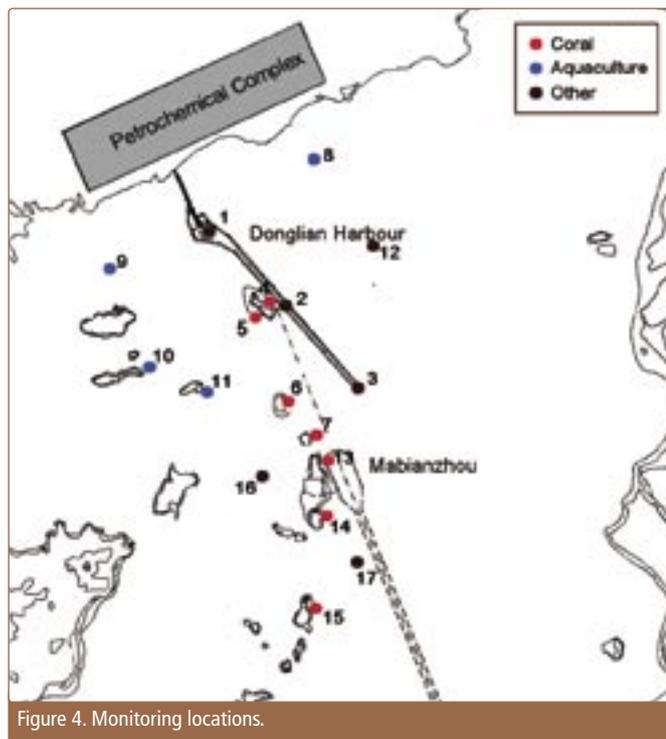
Figure 4. Monitoring locations.

Based on the results of the EIA's 17 locations throughout Daya

Bay were defined for water quality monitoring. The locations defined included: 7 coral sites, 4 aquaculture sites, 3 sites inside the dredging area and 3 sites for background measurements.

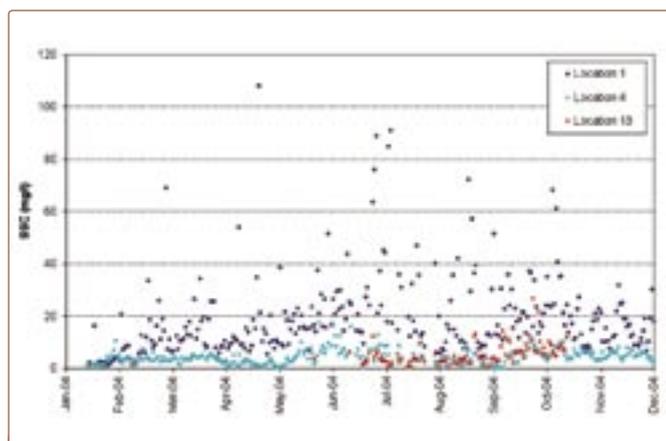
Figure 5. Measured SSC at locations 1, 4 and 13, Jan '04 – Dec '04.

Results of SSC measurements at locations 1, 4 and 13 are plotted in Figure 5. Location 1 is inside the dredging area and on occasions high SSC levels up to 100 mg/ltr were monitored, mainly when dredging activities were undertaken close to the monitoring location during the time of measuring. No environmental limit was applicable for this location.

At the coral sites, which are closest to the dredging area, locations 4 and 13, no exceeding was recorded. Moreover the means of the monitored SSC levels at those locations were in the range of the background SSCs.
