Maximizing the useful life of rubber marine fenders

Ed Kiedaisch, Hi-Tech Marine Solutions LLC, Iowa, USA

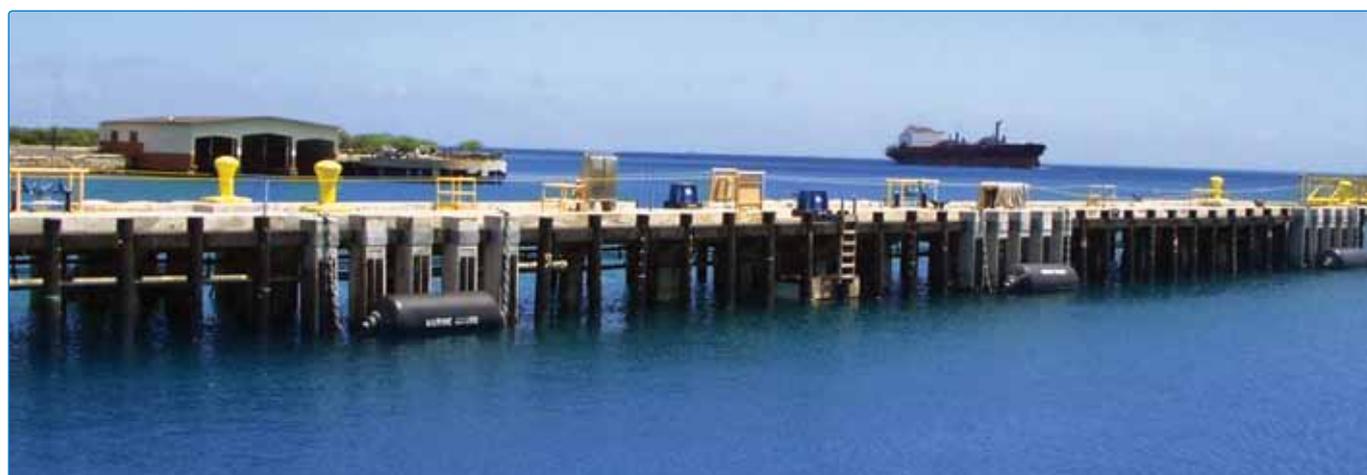
Good design can significantly increase the percentage of potential useful life that fenders actually achieve.
